Comparative full-scale fire performance testing of ETICS systems

University of Zagreb
Faculty of Civil Engineering
Department of Materials

Original scientific paper

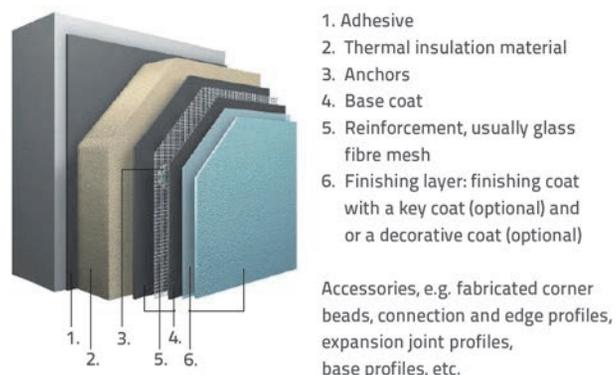
Figure 1. ETICS systems components [3, 4]

The European Union (EU) has defined its energy policy for overall energy efficiency and has harmonised this policy with the Energy Saving Legislation and other Instruments, all of which is aimed at reviving European economy [1]. The overall energy efficiency implies reduction of energy consumption in buildings, since buildings account for 40 % of the EU energy use and 36 % of its overall CO₂ emissions [2]. The energy performance of buildings can primarily be improved through implementation of thermally enhanced building envelopes. Among several possible technologies to thermally enhance building envelopes, *External Thermal Insulation Composite Systems* (ETICS) (Figure 1) are the most commonly used façade systems in Europe.

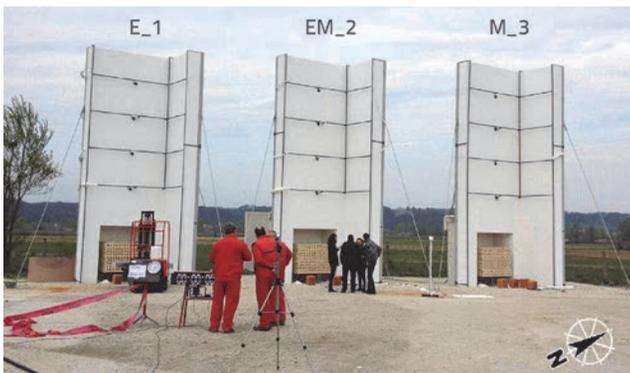
Figure 4. Test specimens before testing

All three test specimens were L-shaped, 8 m high, with one leg forming the main test wall (main face) 2.6 m in length, and the other leg forming the return wall (wing) 1.5 m in length, as shown in Figure 4. The L-shape of the specimens represents a corner of a building. The only difference between test specimens was the type of thermal insulation material used in the ETICS system erected on the brick wall, i.e. combustible expanded polystyrene (EPS) and non-combustible mineral wool (MW) thermal insulation. The composition of all three test specimens and their classification according to the reaction to fire as declared by the manufacturer [4, 5] is shown in Table 2.

Since the test was performed outside, relevant weather conditions, i.e. wind speed, wind direction, and air temperature were monitored during the test. Air temperature during the test was within the range of 20.5 – 22.2 °C and the air velocity was within the range of 2.2 – 4.5 m/s in the N, N-W direction. The north direction is shown in Figure 4.

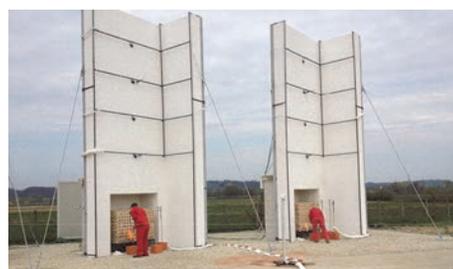
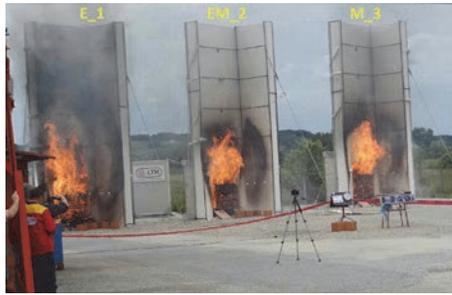
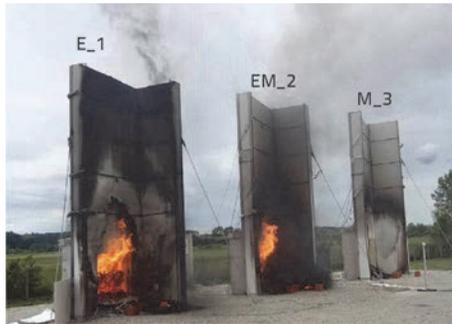
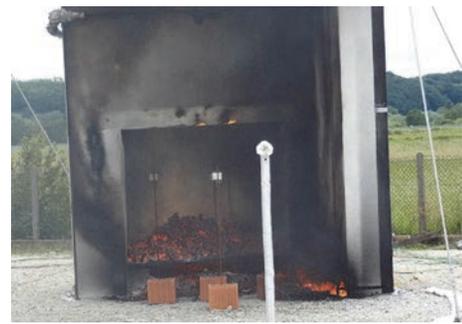
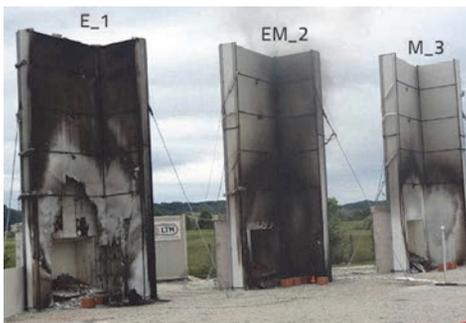
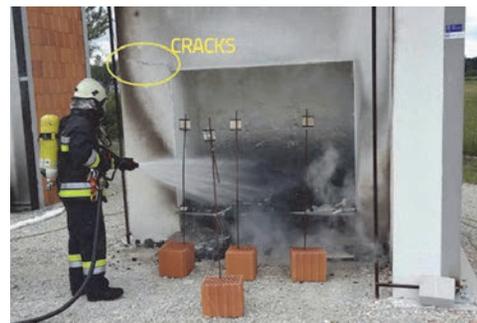
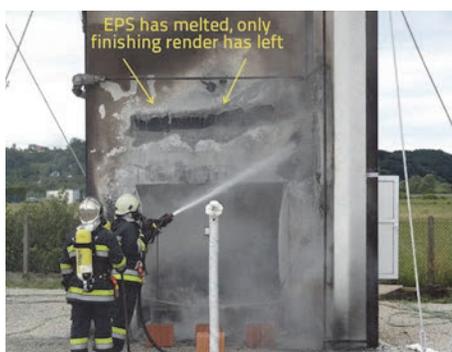
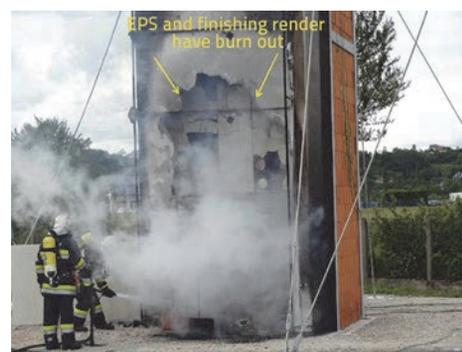
Figure 9. Ignition of wood crib – start time

Figure 10. 9 min from the start

Figure 11. 19 min from the start

Figure 12. 28 min from the start

Figure 13. 37 min from the start

Figure 14. 54 min from the start – smoldering at test specimen EM_2

Figure 15. 57 min from the start – wood crib has burned up

Figure 16. 64 min from the start – firefighters watering M_3 for safety reasons

Figure 17. 66 min from the start - firefighters watering EM_2 for safety reasons

Figure 18. 67 min from the start - firefighters watering E_1 for safety reasons

The development and fire spread at all three specimens, and fire performance of these specimens, are presented in Figures 9 to 18. Visual observation during the test revealed that the fastest fire spread, both vertically and horizontally, was registered at test specimen E_1 and was accompanied with significantly greater smoke production compared to other specimens, Figure 11 and Figure 12. The fire spread at test specimen EM_2 was mitigated due to presence of fire barrier above the combustion chamber. Hence, the average surface temperature (Figure 8), and average temperatures within the thermal insulation layer (Figure 21) of this test specimen, were significantly lower

More than 60 minutes from the start, firefighters hosed down fire sources and all test specimens for safety reasons. Only the glass fibre mesh and finishing render was left of test specimen E_1, while the entire thermal insulation was burned up in less than 40 min after the start of fire. At test specimen EM_2, once the fire propagated over the fire barrier above the combustion chamber, the thermal insulation started to melt and burning droplets fell down. The thermal insulation melted only partially at this test specimen. At test specimen M_3, only a few cracks were detected above the combustion chamber after watering by firefighters, and only organic render finishing was burned out. The thermal insulation at test specimen M_3 was not significantly damaged.

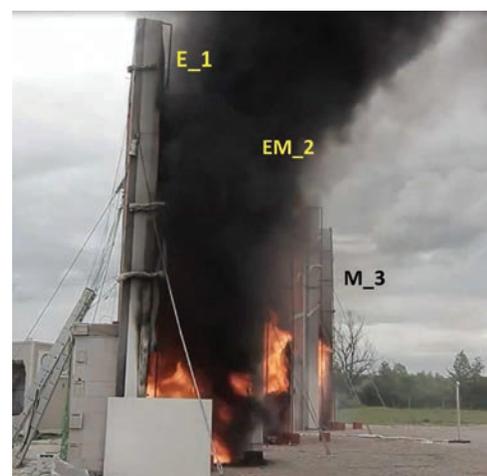
Figure 23. Great smoke production and droplets burning on the ground (specimen E_1): 25 min from start

21 min	Second surface peak	Over 600 °C	Level 1	19.a	
		Over 300 °C	Level 2	20.a, 22	
25 min	Third surface peak	Over 550 °C	Level 1	19.a, 23	Burning droplets on the ground, followed by great smoke production.
		Over 300 °C	Level 2	20.a, 23	
25 – 60 min	Decay stage of fire development curve	Temperatures are decreasing	Level 1	19.a	EPS was completely burned up.
			Level 2	20.a
